## **A Spatial Analysis of the Relationship between Pedestrian Crash Events and Features of the Built Environment in Downtown Atlanta**

A Thesis Submitted to the Graduate Faculty of Georgia State University in Partial Fulfillment of  
the Requirements for the Degree

Master of Public Health

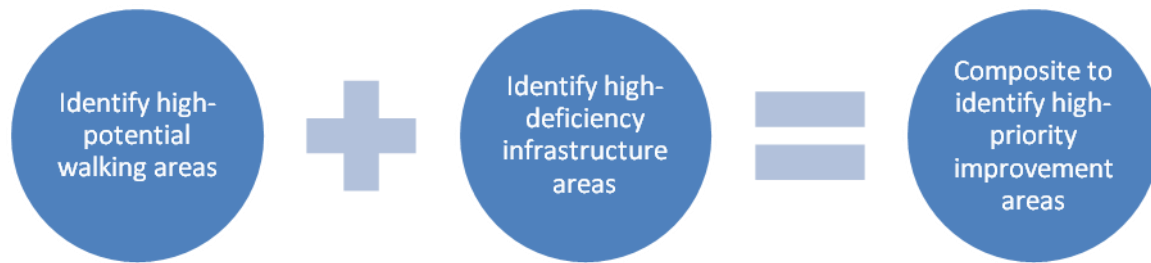
**Figure 2.1 Two indices used in the Ped INDEX methodology to identify high-priority areas**  
(City of Sacramento, n.d.)

These indices approach pedestrian infrastructure design from a more comprehensive viewpoint by identifying two different indices: improvements that need to be made to the built environment and factors that will facilitate more motivation for walking. These indices account for infrastructural deficiencies such as broken sidewalks, lack of crosswalks, and poor street lighting, as well as factors that will encourage pedestrian travel, such as pleasant streetscape, street connectivity and close proximity to destinations (City of Sacramento, n.d.).

After the inventory is completed, maps are created in order to visually convey the areas that are in most need of improvements. A composite score of both infrastructure deficiencies and pedestrian potential are compiled to determine pedestrian improvement need. The final process consists of prioritizing individual projects based on factors such as cost/benefit ratio, level of community support, and possible sources of funding. Through this process, improvement projects that can most feasibly be carried out will take priority over those without the same level
