URBAN STREAM CHANNEL GEOMORPHOLOGY: INVESTIGATING THE SHORT-TERM CHANNEL STABILITY  
AND BED-MATERIAL TRANSPORTATION WITHIN A REHABILITATED URBAN STREAM REACH IN DEKALB  
COUNTY, GEORGIA

A Thesis Submitted in Partial Fulfillment of the Requirements for the Degree of

Master of Science

Georgia State University

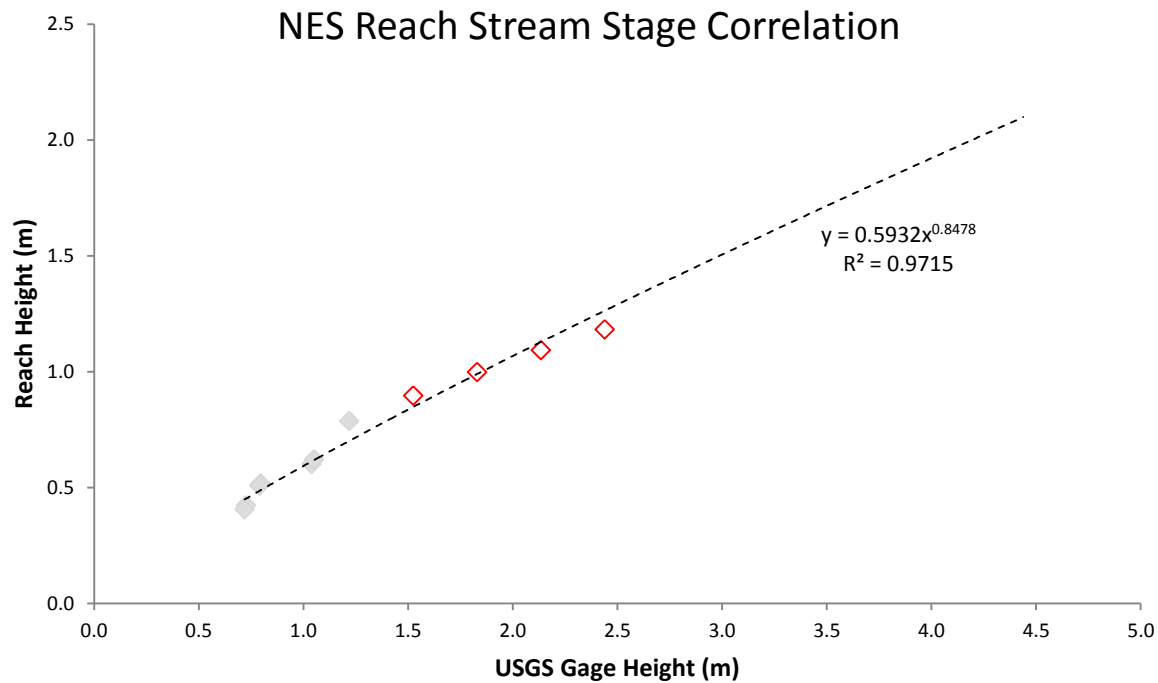
**Figure 1.3 – Reach flow stage determination**

Stage correlation for NES with a curve based on incorporating between-gauge correlations. Grey points represent the original staff readings and the red outlined points are translated from downstream USGS gauge site.

Eight points were initially used to set up the correlation curve between the study reach and the active stream gauge upstream (reach-gauge correlation) and the highest flow measured 0.98 m at the USGS station. Only using these low flows would not have sufficed for this study, particularly due to the interest in sediment transportation at higher stages. To account for larger flows occurring in the study reach, an additional correlation was set up using the above USGS gauge and a second operational gauge (USGS 02203560) which was located  $\pm 3$  km downstream of the study site (between-gauge correlation). Because there were no major tributaries entering between the study reach and this southern gauge site, it was considered practical to use the regression curve for between-gauge correlation and translate this

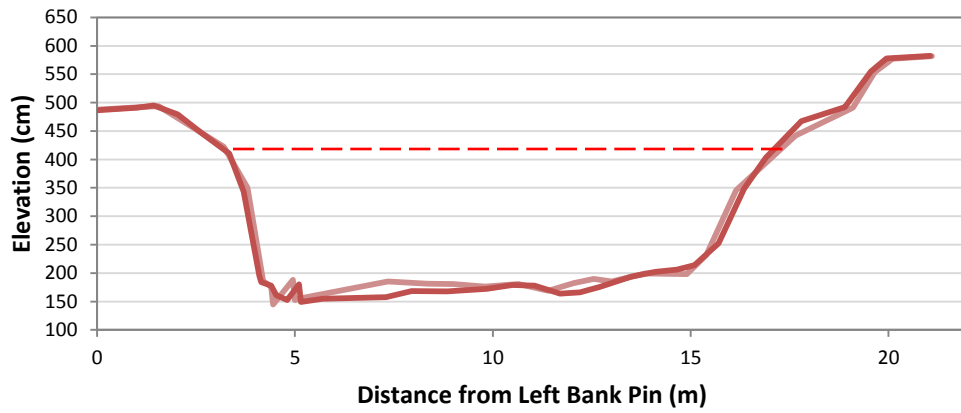
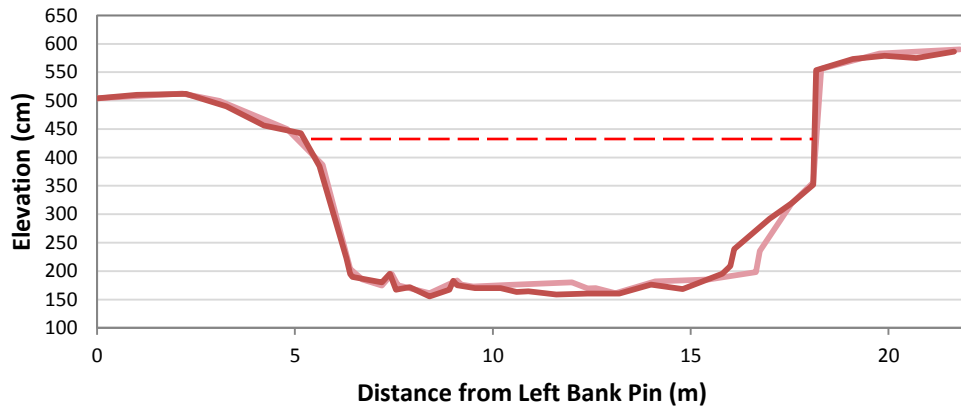
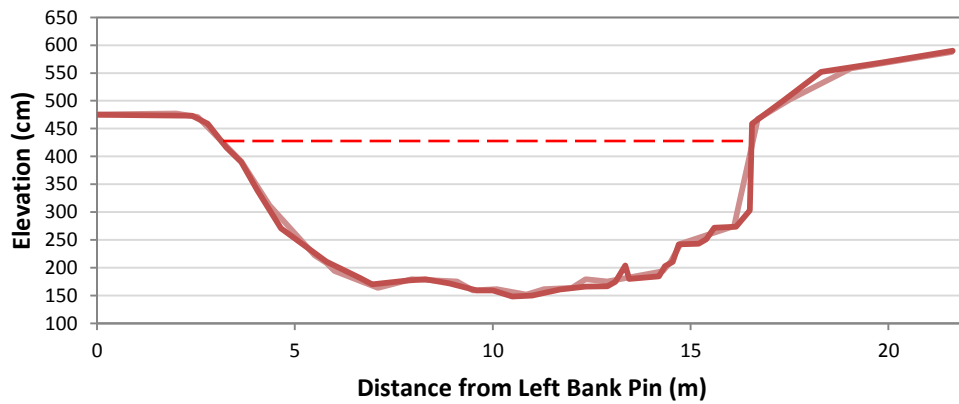
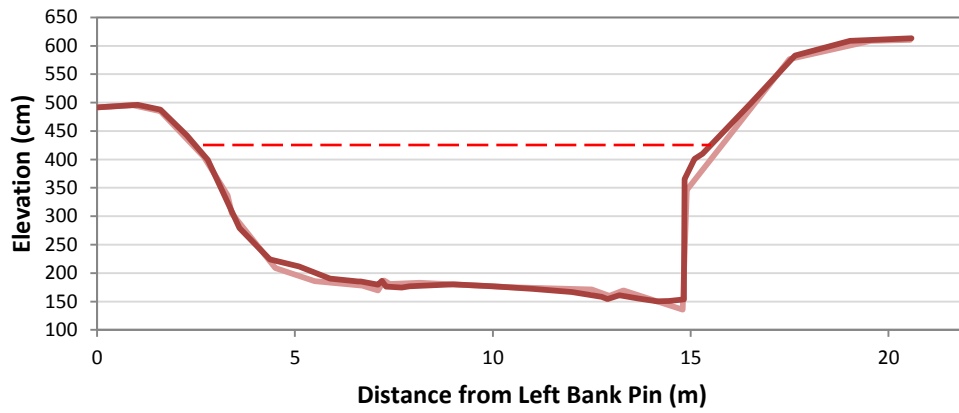
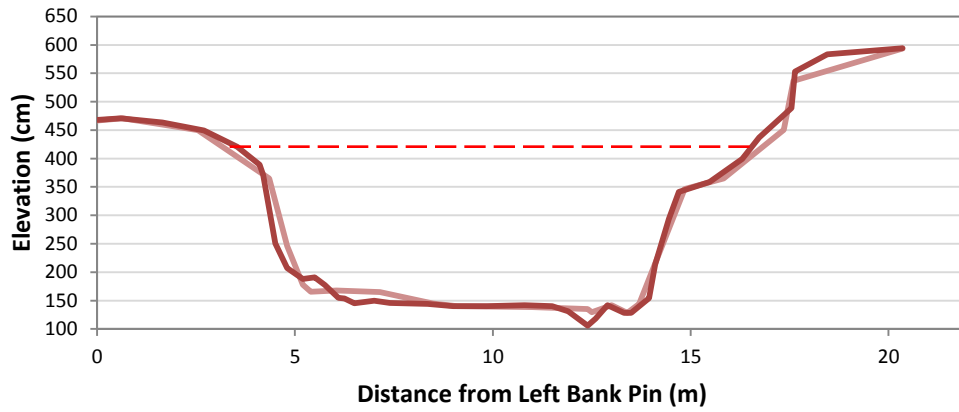
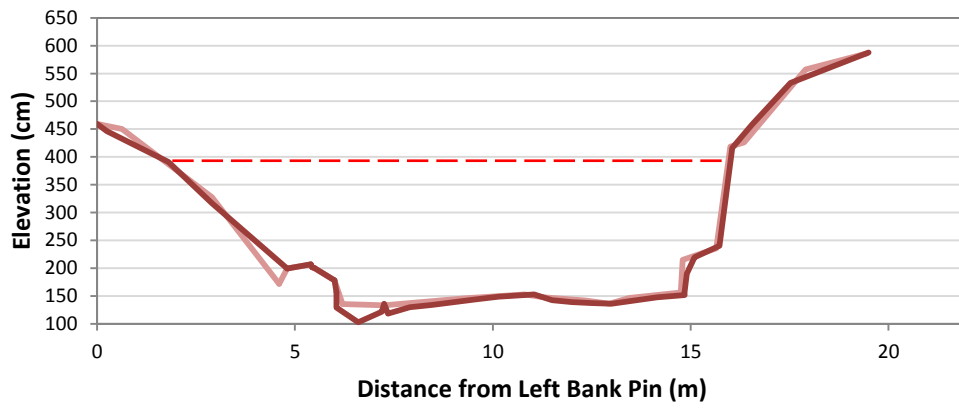
**Figure 3.1 – Control Site cross-sectional analysis**

Cross-sectional plots of pre- and post-flood channels in the CS. The red, dashed line denotes the high flow mark used for the area calculation.

For the most part the CS experienced predominant channel erosion over the duration of the study period. As with the NES, there was a migration of the thalweg channel as meandering tended to scour new low-flow channels and degrade existing channel bars (Figure 3.1). The resurvey of these channel banks along precisely the same transect line was complicated by the presence of tree roots, overhanging banks, and persistent vegetation cover. The comparative measurements of changes in bank dimension were therefore adjusted in the spreadsheet calculations to compensate for any anomalous bank adjustments. Bank aggradation did however take place along the left bank above a log in the channel along the pin 6 transect of and on the right bank along the pin 2 transect. The largest erosion took place below a channel debris constriction upstream of the pin 1 transect causing the removal of mid-channel bars (Figure 3.1 and Figure 3.2).

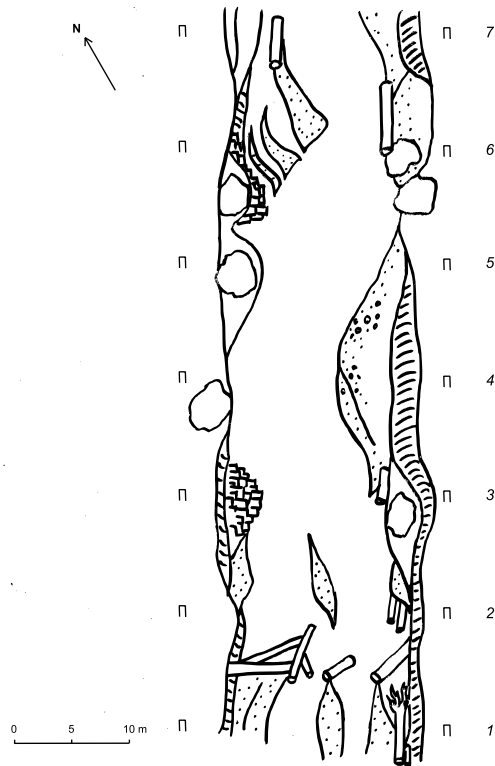
**Figure 3.2 – Control Site sketch**

Interpretation of the CS channel with locations of cross-section transects numbered in the upstream direction.

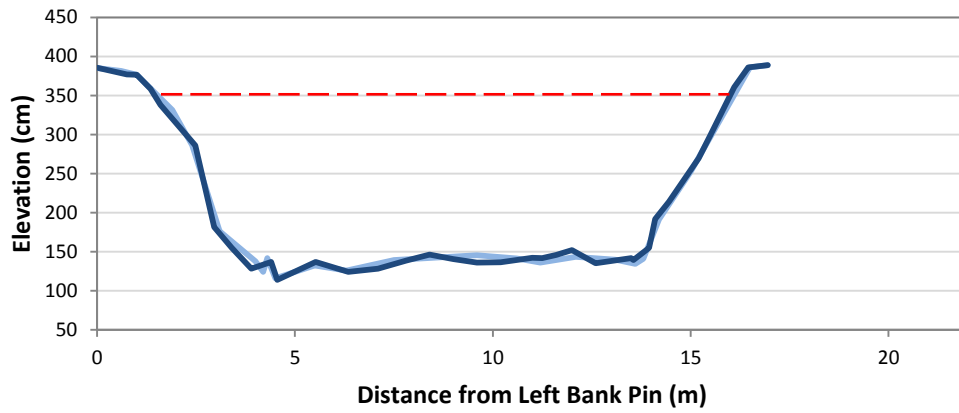
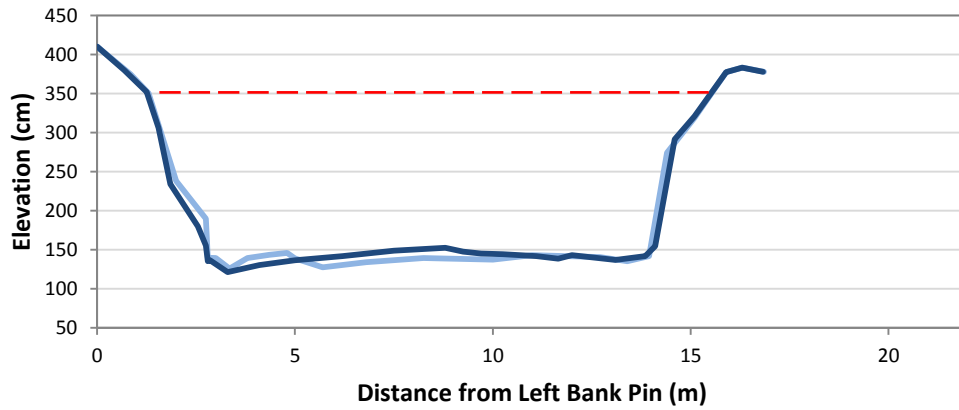
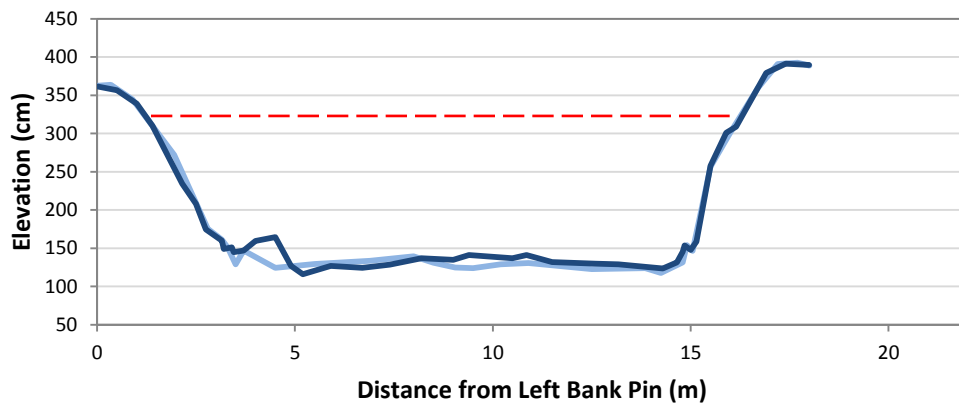
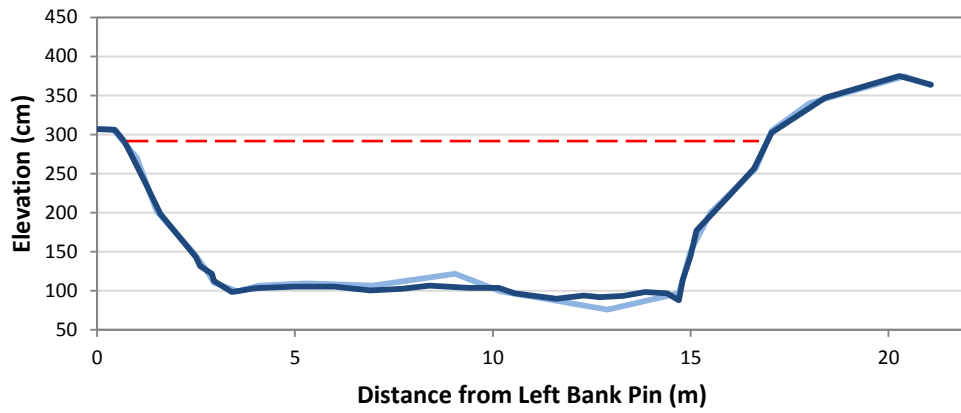
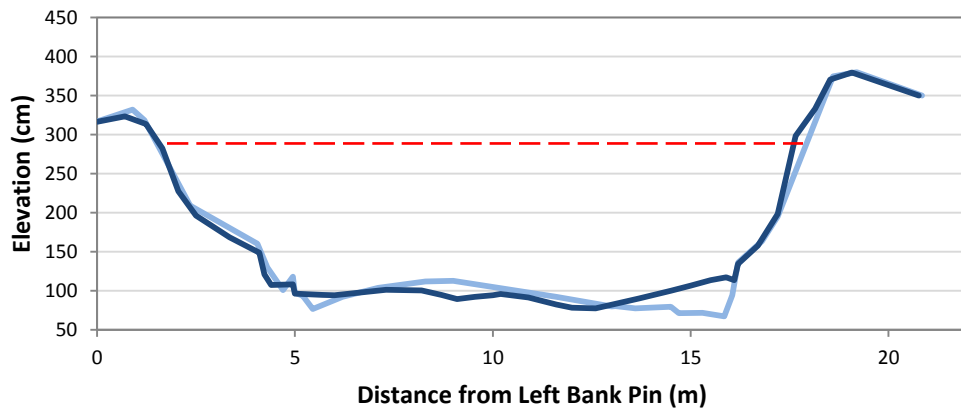
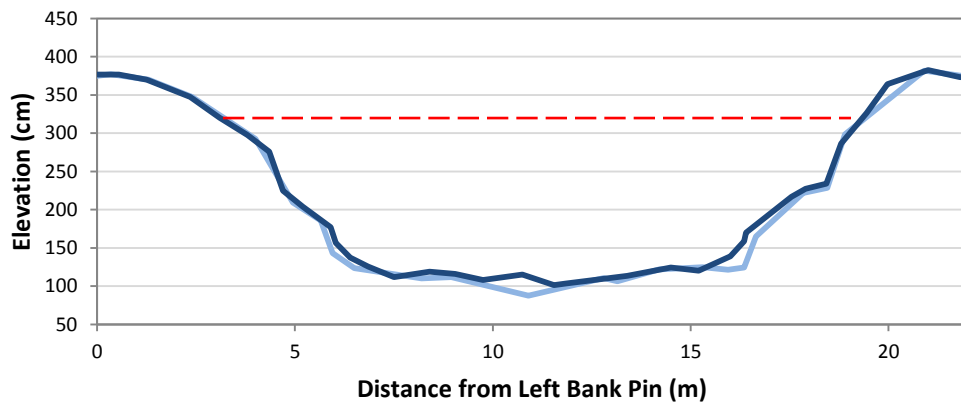
**Figure 3.3 – North Experimental Site cross-sectional analysis**

Cross-sectional plots of pre- and post-flood channels in the NES. The red, dashed line denotes the high flow mark used for the area calculation.

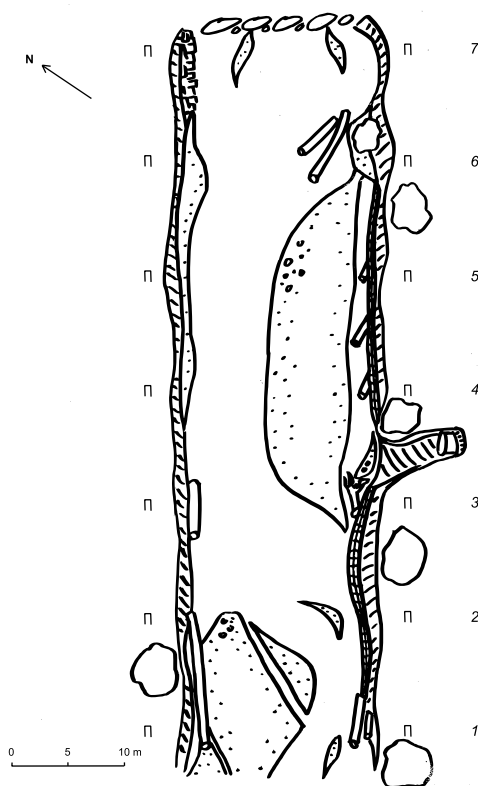
**Figure 3.4 – North Experimental Site sketch**

Interpretation of the NES channel with locations of cross-section transects numbered in the upstream direction.

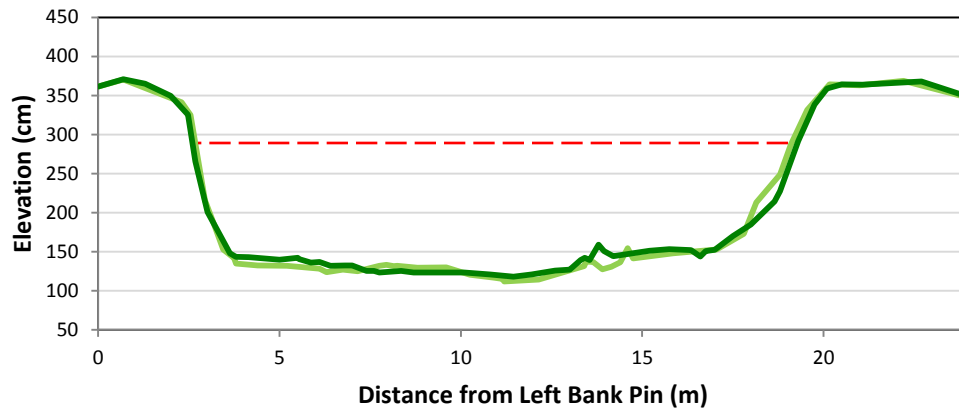
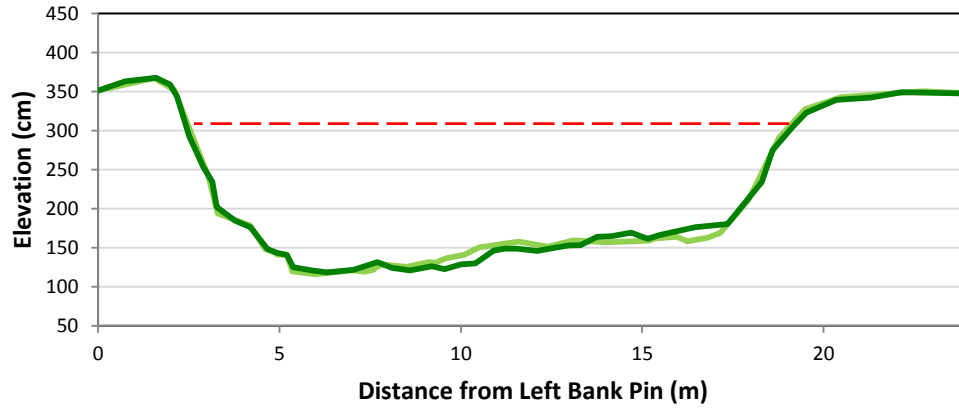
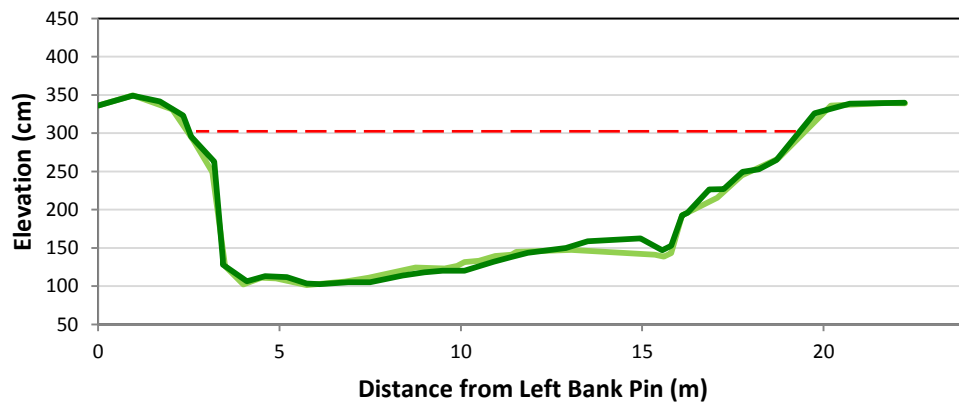
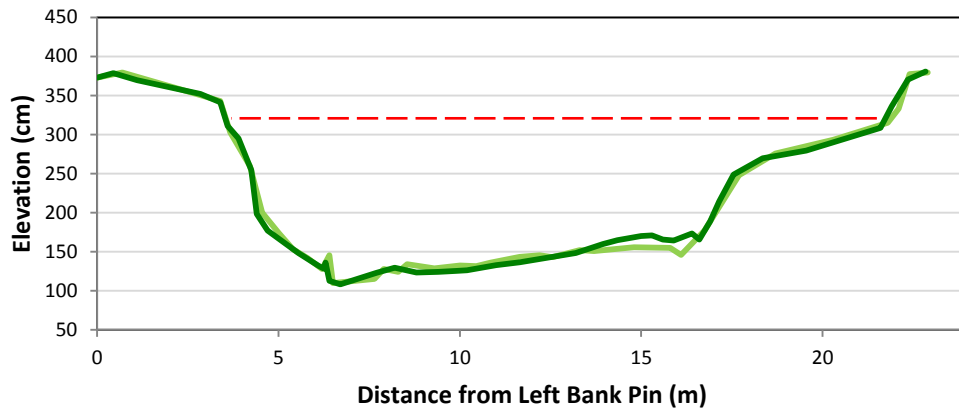
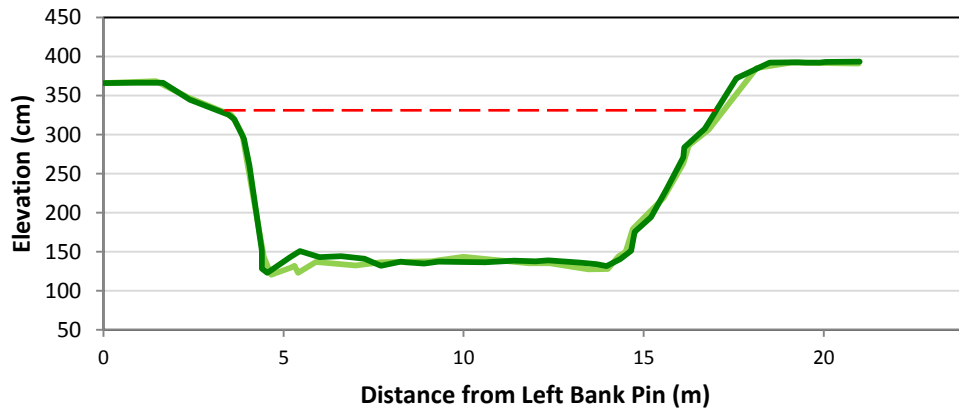
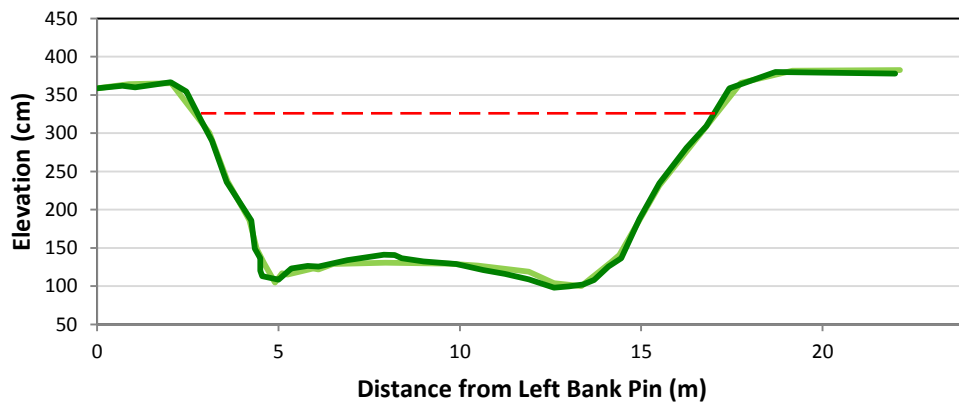
**Figure 3.5 – South Experimental Site cross-sectional analysis**

Cross-sectional plots of pre- and post-flood channels in the SES. The red, dashed line denotes the high flow mark used for the area calculation.

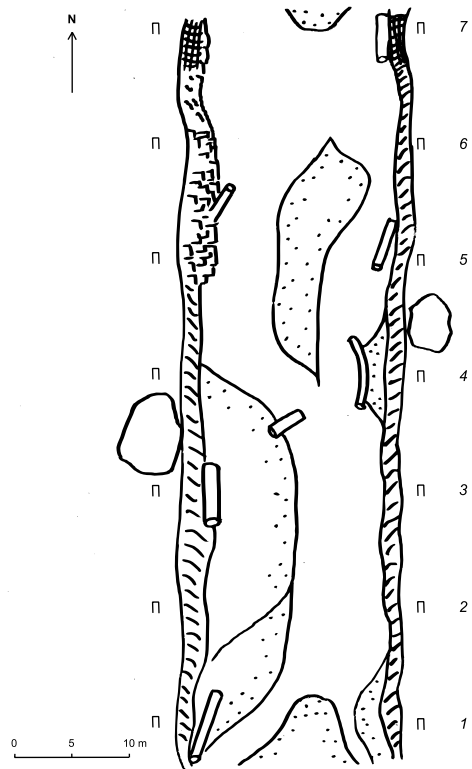
**Figure 3.6 – South Experimental Site sketch**

Interpretation of the SES channel with locations of cross-section transects numbered in the upstream direction.

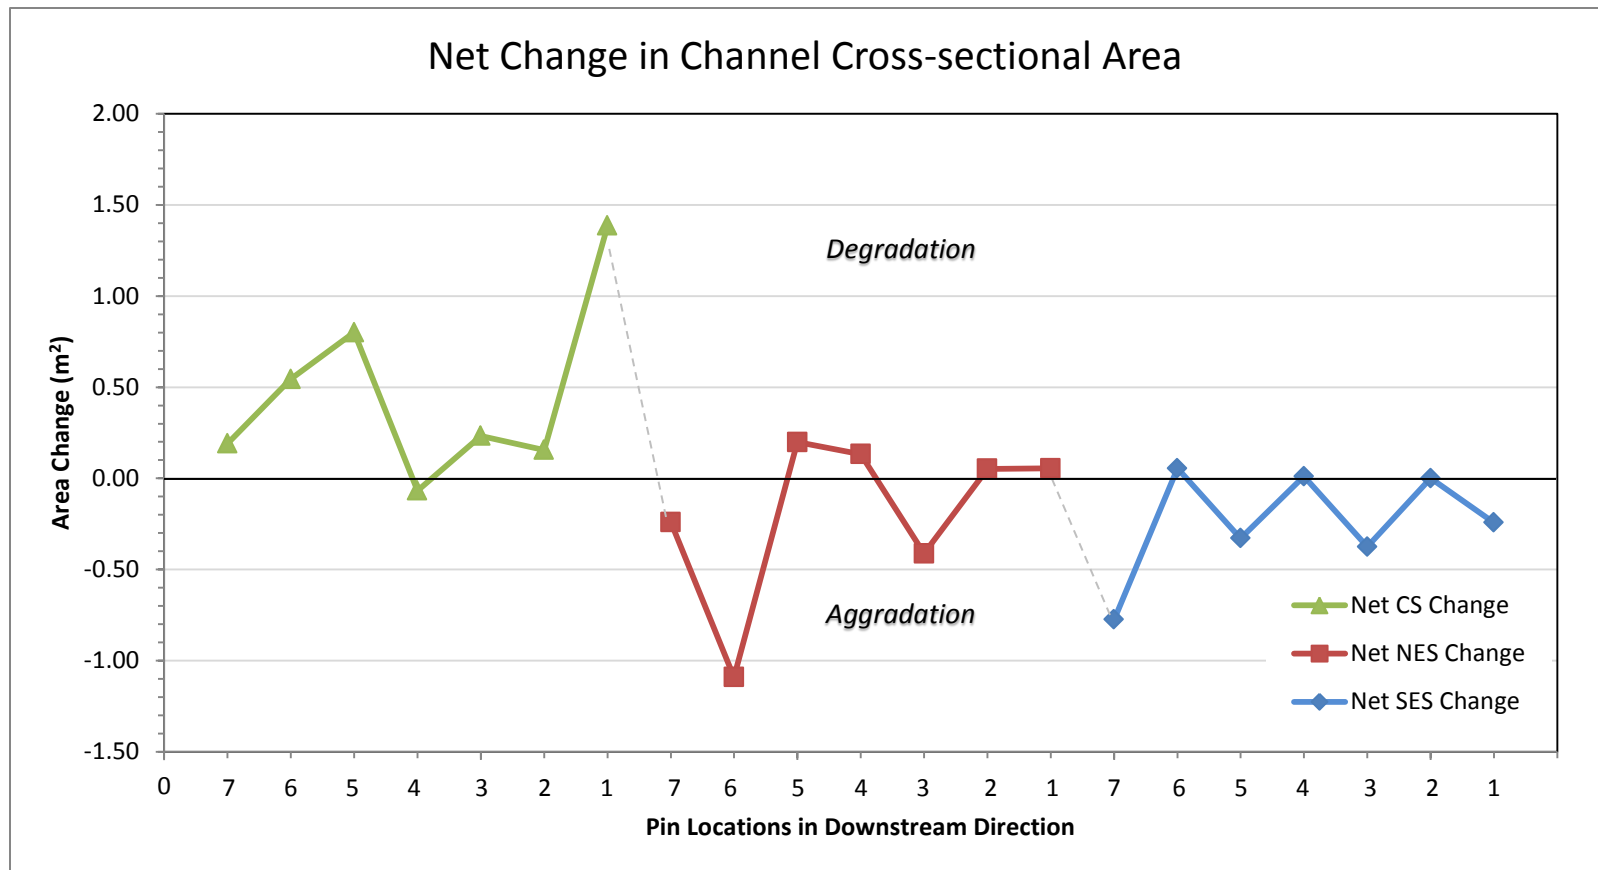
**Figure 3.7 – Plot of channel area alterations**

Changes in Cross-sectional geometry associated with the amount of scour (degradation) and fill (aggradation) experienced in each reach from the upstream to the downstream sites per transect pin in each site. Distances between pins and sites are not shown here.

The average of the net changes experienced in all transects revealed that the two experimental reaches displayed a largely aggradational trend in channel modification (NES = -0.7 % or  $-0.2 \text{ m}^2$ , SES = -1.0 % or  $-0.2 \text{ m}^2$ ) compared to the CS which had greater degradational channel characteristics (+1.7 % or  $+0.5 \text{ m}^2$ ) (Table 1). A definite pattern of upstream degradation becoming progressively more aggradational downstream was visible when looking at the average changes from CS through SES in Figure 3.7.

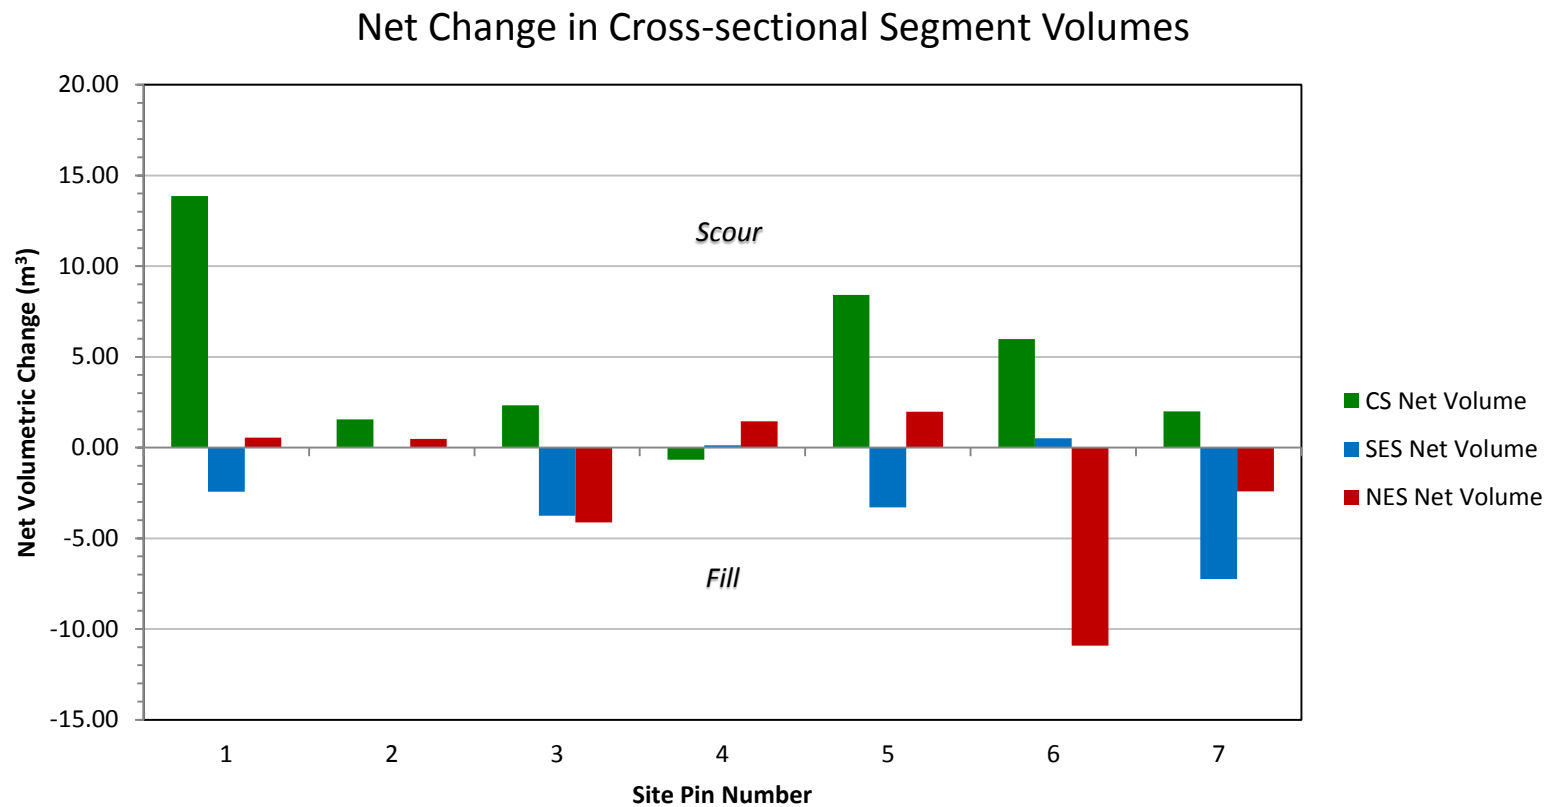
**Figure 3.8 – Plot of volumetric channel changes per cross-sectional segment**

Results showing the volumetric sediment gains and losses for each channel in the study reach. Positive values indicate a bed-material loss and negative values denote bed-material accumulations.

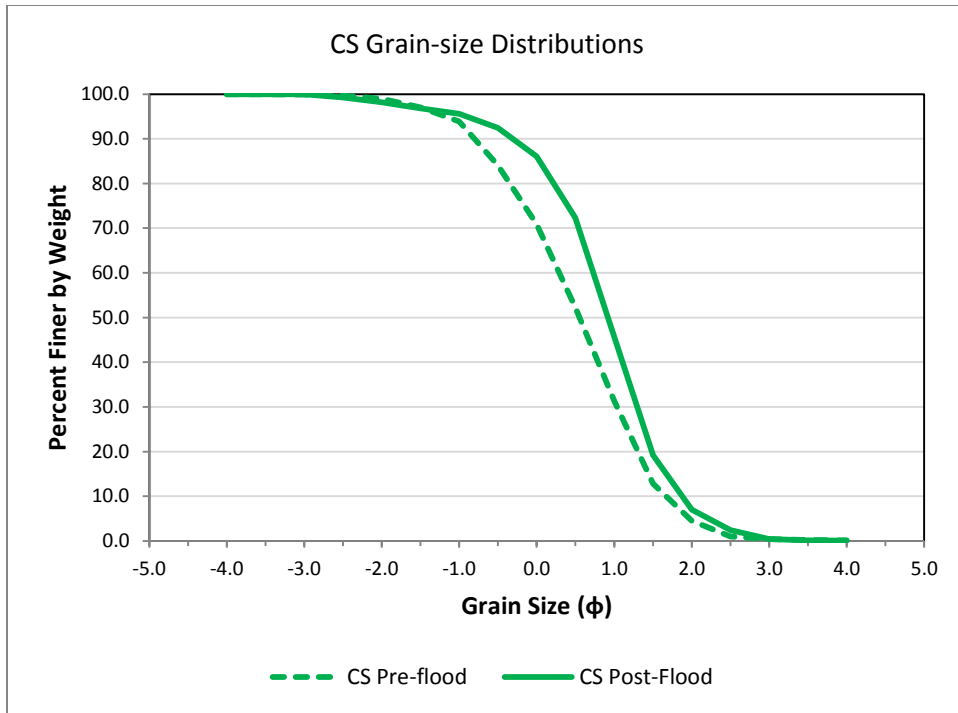
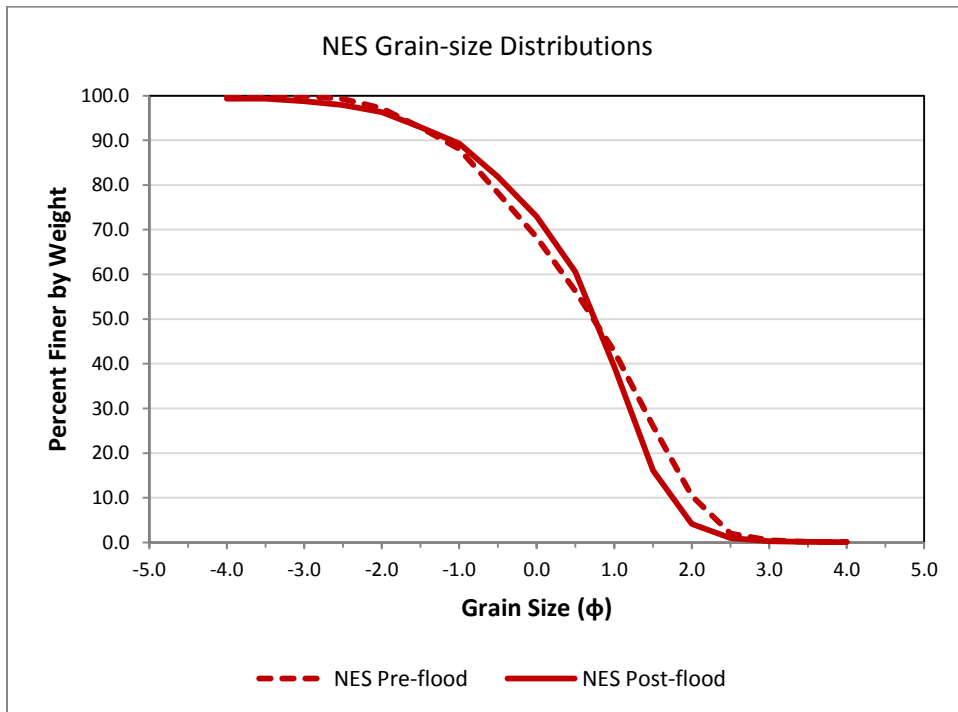
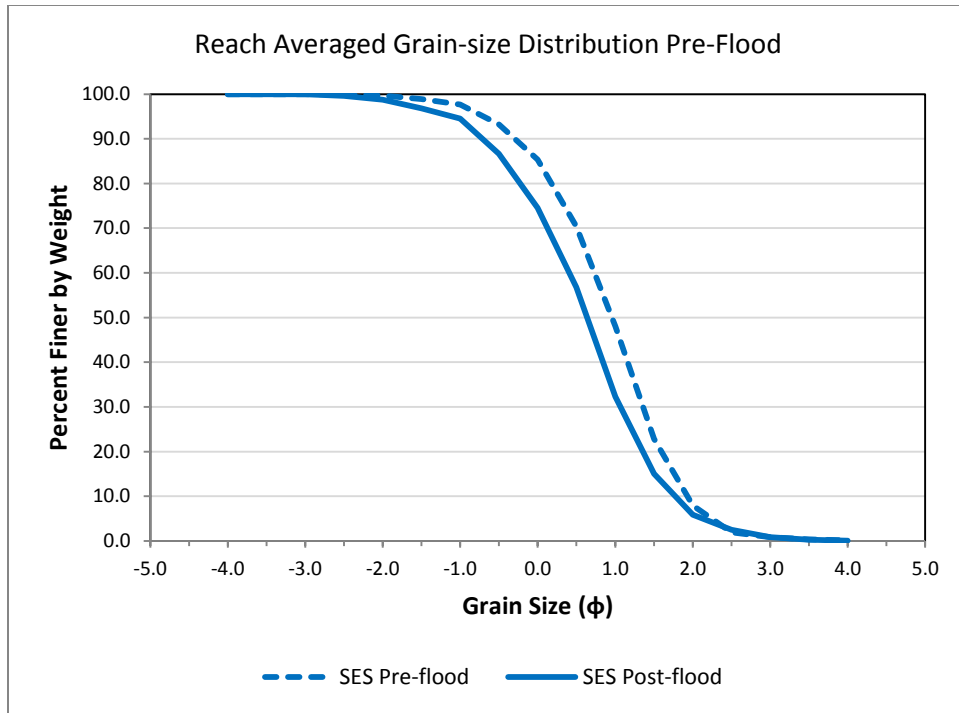
**Figure 3.9 – Grain-size distribution plots**

Graphical representation of the change in the averaged grain-size distribution for each site over a series of effective discharge events.

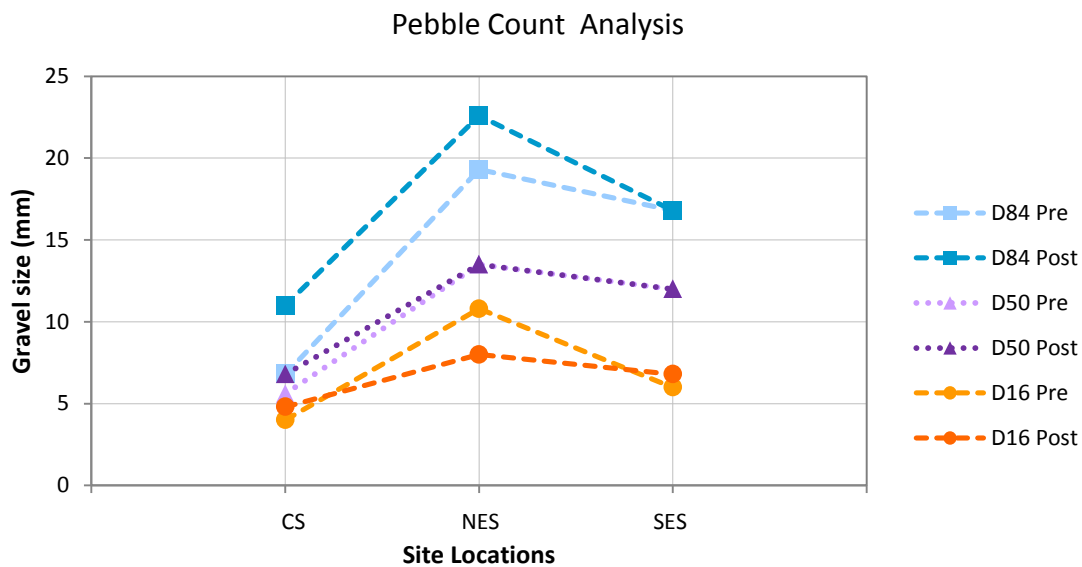
**Figure 3.10 – Channel bed surface gravel analysis**

Pebble count results showing the surface bed-material changes as measured by pre- and post-flood samples in each site. The horizontal axis represents the relative downstream site locations and the vertical axis shows gravel caliber.

Each of the sites was represented by two pebble samples, which were averaged to give the median  $D_{16}$ ,  $D_{50}$  and  $D_{84}$  grain sizes. Resampling took place at a slightly higher stream stage compared to pre-flood sampling and this may have caused coarser gravels to become preferentially more exposed. Although the resulting changes in all three sites were not significant ( $p > 0.05$  for  $\alpha = 0.05$  using Mann-Whitney and t-test) (Table C), the experimental reaches both had a greater proportion of coarse surface material relative to the control site. The NES had the coarsest surface gravels both before and after floods (Figure 3.10), with samples generally becoming more variable to a degree (i.e. both coarser and finer), while keeping  $D_{50}$  unchanged. This coarseness of gravels corresponds to the fact that this site also

had the coarsest  $D_{84}$  for the grain-size analysis, therefore implying a local gravel source to the reach. The CS experienced a coarsening of all three grain size fractions. There was little significant gravel representation in this channel and the bed roughness seemed to be dominated instead by bed-forms such as ripples.
