Public Health Capstone Projects

School of Public Health

## Comparing Water Quality Data of Atlanta's Sewage Overflows and Spills

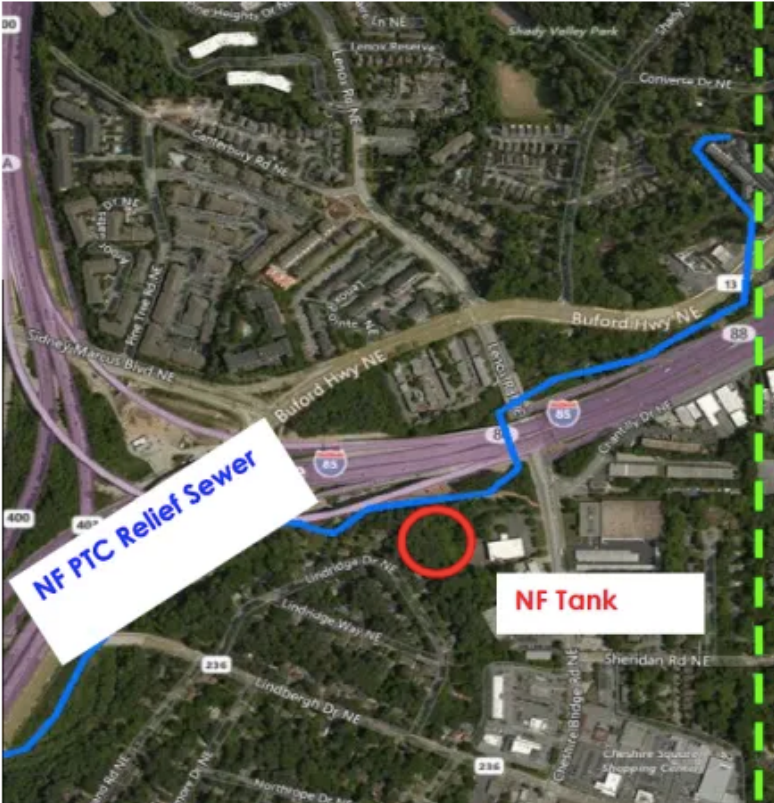
Figure 5.1 A map showing the proposed location for a new storage tank near I-85 impacting Peachtree Creek Basin and Peachtree Battle Avenue (retrieved from Reporter Newspaper)

Figure 5.1 Atlanta's Watershed Department Proposed Storage Tank Near I-85, 2018
